# Lower Rio Grande Water Quality Monitoring Feasibility Assessment

by  
David Buzan, Freese and Nichols, Inc.  
Nick Landes, Freese and Nichols, Inc.  
Pilar Corpus, SDI Engineering, LLC.  
Jungseok Ho, University of Texas Pan American

December 7, 2015

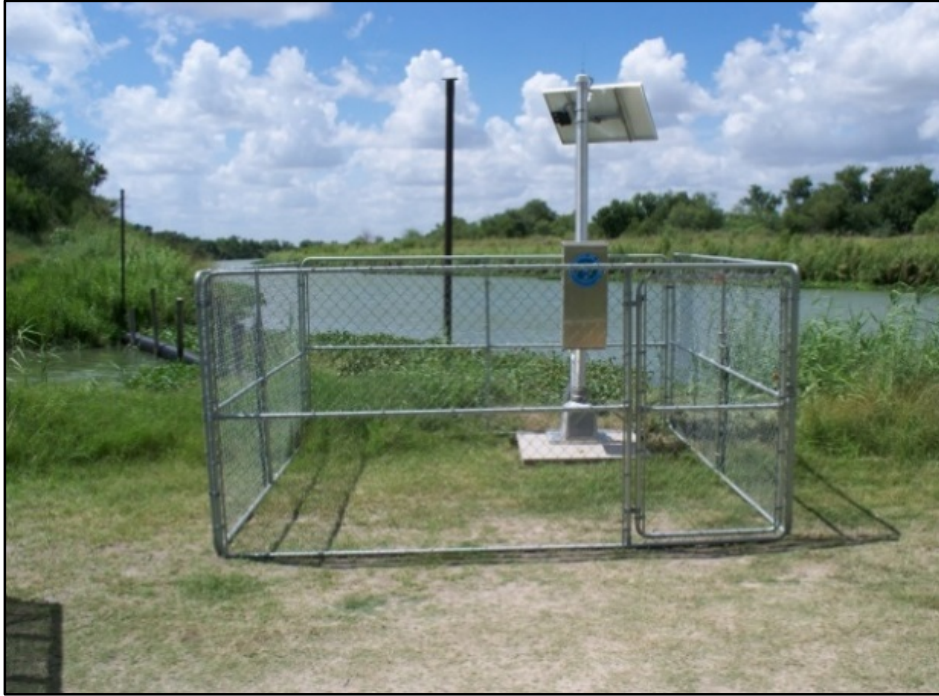
**Figure 5.** CAMS 789, Rio Grande at the Harlingen Irrigation District (ID) Diversion. View downstream with the irrigation diversion to the left and the Rio Grande flowing from right to left. Photo by TCEQ.

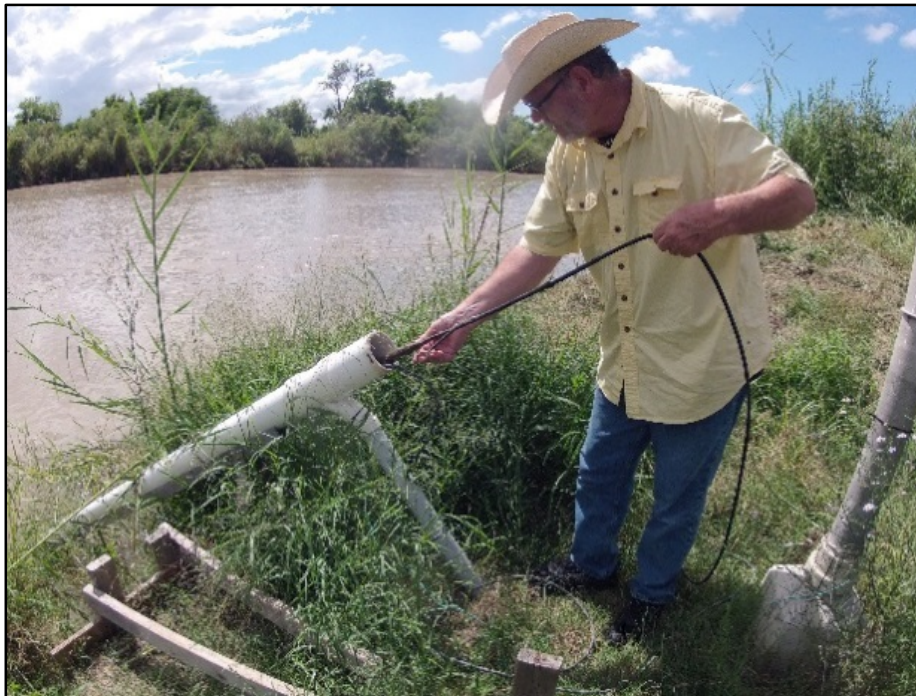
**Figure 6.** CAMS 789. Retrieving the water quality meter from the Rio Grande. Photo by Freese and Nichols, Inc. September 29, 2014.

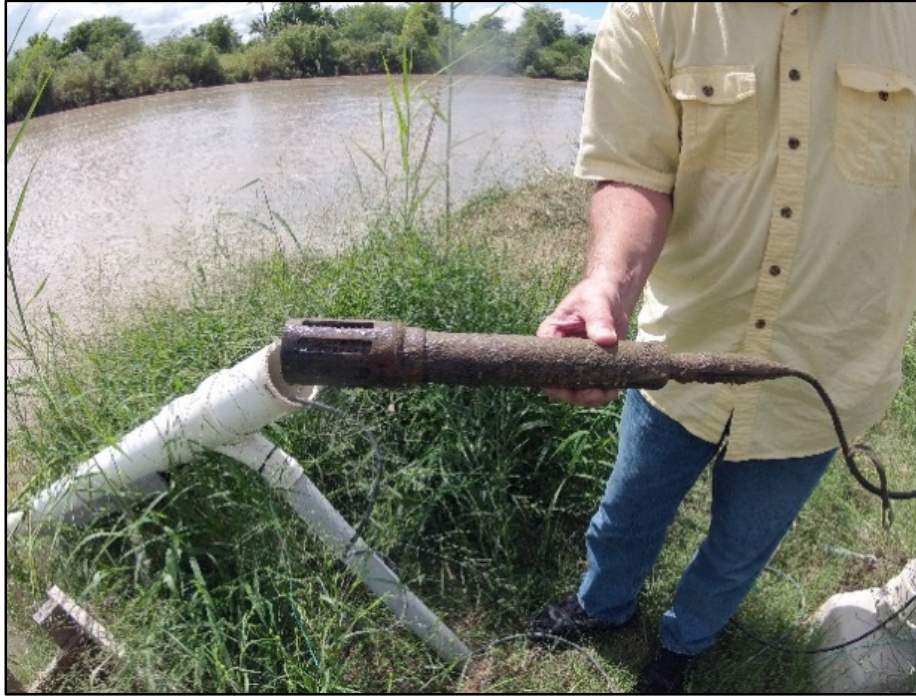
**Figure 7.** CAMS 789. YSI water quality meter immediately after retrieval from the river. Photo by Freese and Nichols, Inc. September 29, 2014.

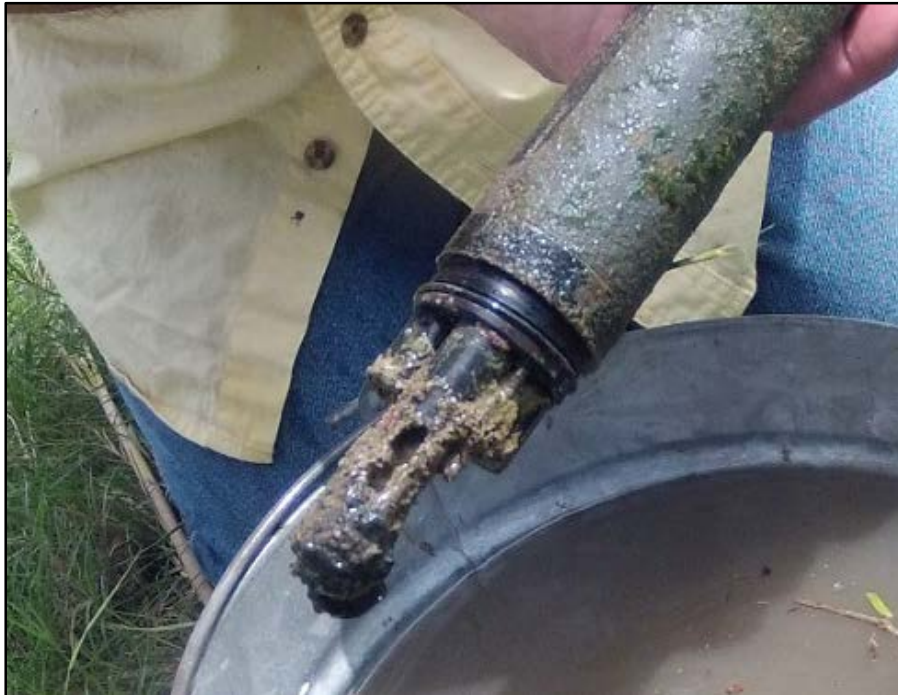
**Figure 8.** CAMS 789. YSI water quality meter with fouling on probes. Photo by Freese and Nichols, Inc. September 29, 2014.

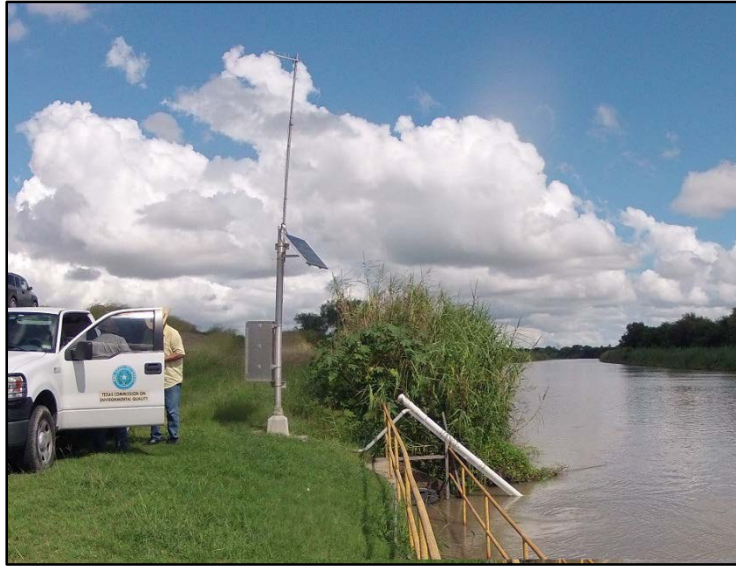
**Figure 9.** CAMS 793. View downstream. Photo by Freese and Nichols, Inc. September 29, 2014.

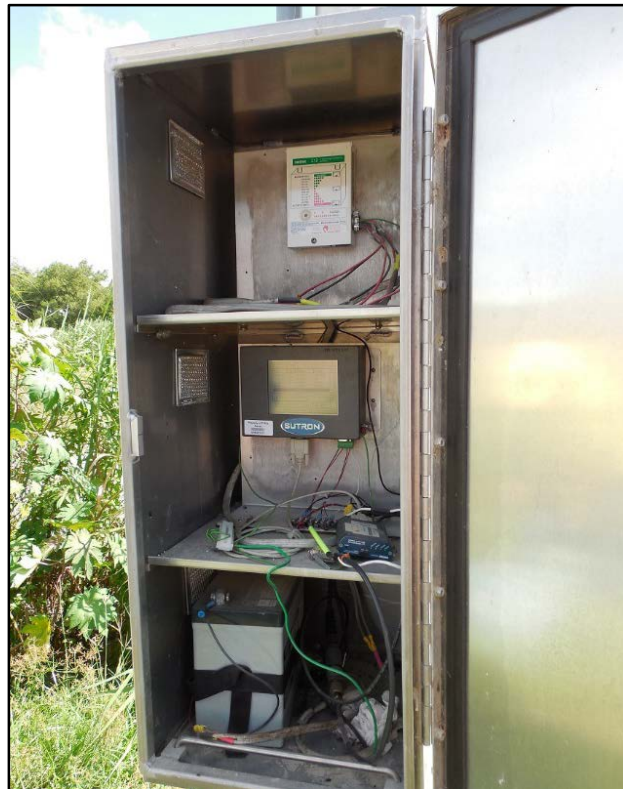
**Figure 10.** CAMS 793. View of control box. Battery on bottom shelf and control/communication system on middle shelf. Photo by SDI Engineering, LLC. September 29, 2014.

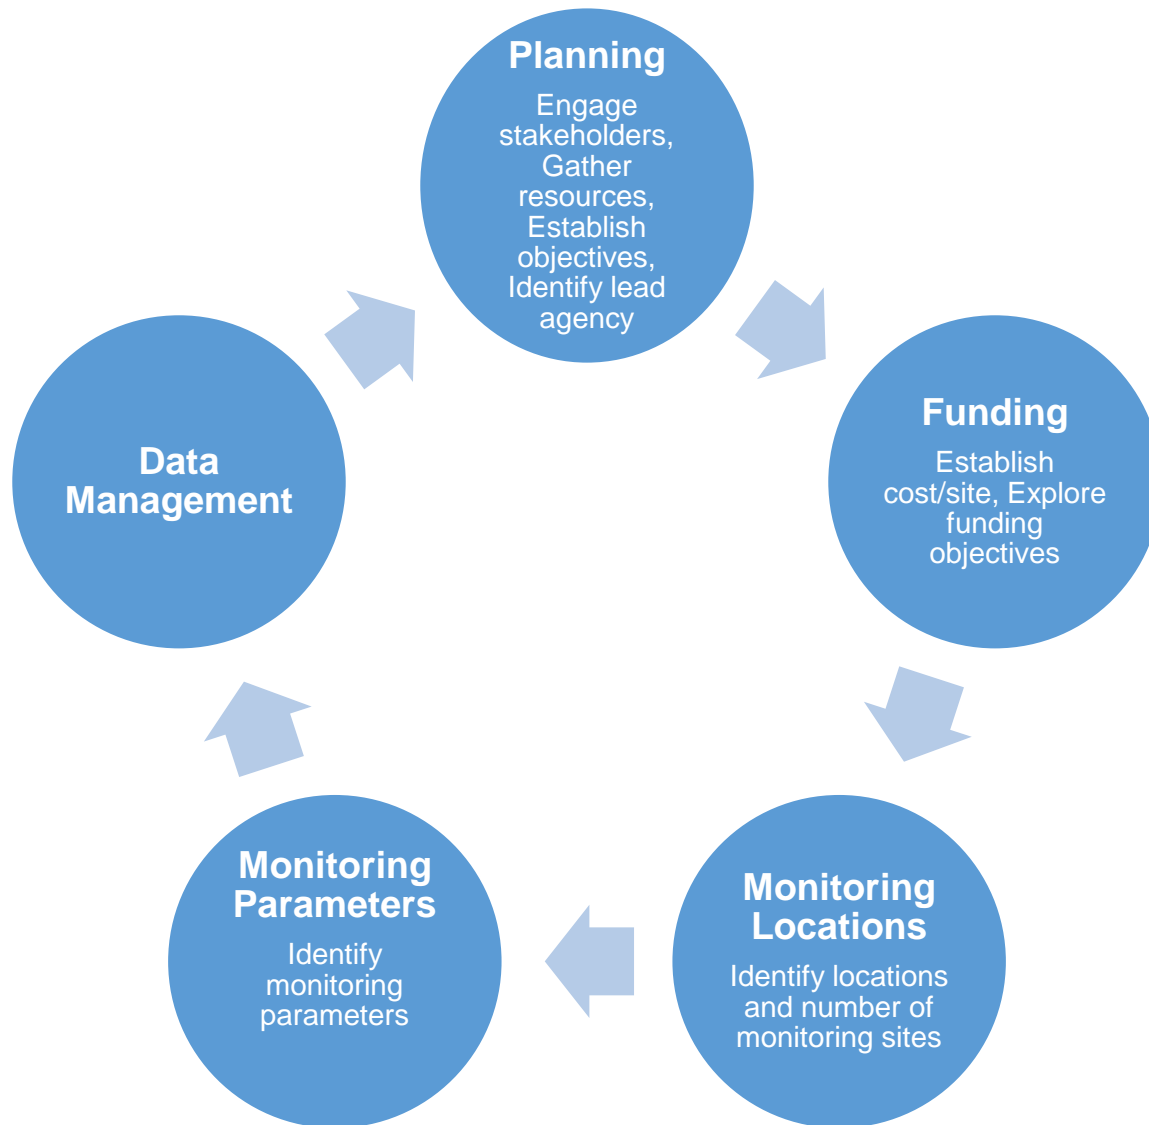
**Figure 12. Scenario for development and operation of an early warning system.**

The following scenario illustrates how an early warning system to monitor taste and odor substances and potentially hazardous materials in the Rio Grande may be approached (Figure 12). It is a conceptual example, not a recommendation. This scenario is a phased approach, providing utilities an opportunity to build the program in steps rather than build a major program from the start with a major investment. It is a cyclic approach which encourages partners to

return periodically to the planning phase to reevaluate objectives, partnership agreements, and set future directions. Cincinnati Ohio’s water system spent \$2.5 million to implement the sampling analysis component of its water security initiative (EPA, 2014). Lessons learned from Cincinnati and other pilot projects should save money and effort building future early warning systems.

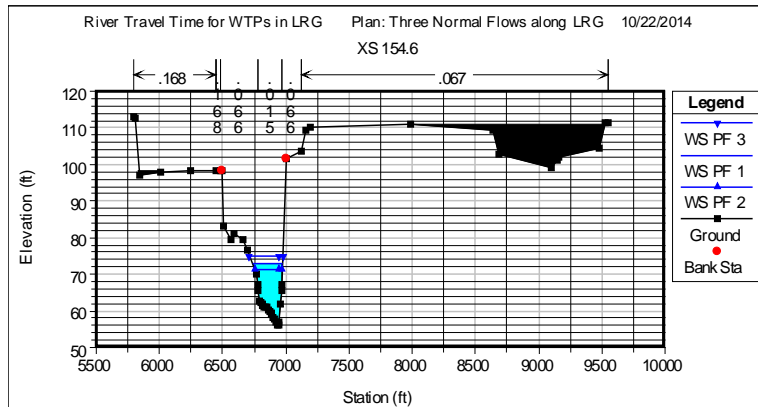
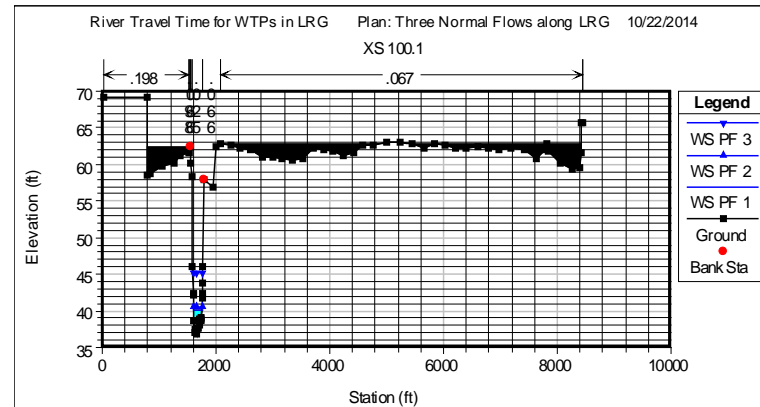
(a) HCUD2

(b) Harlingen ID

Figure A3. Water surface level in cross sections at (a) HCUD2 and (b) Harlingen ID

- Figures A2 and A3 shows the computed water surface profiles (WSPs) of the model reach and cross sectional views of the selected River Intakes.

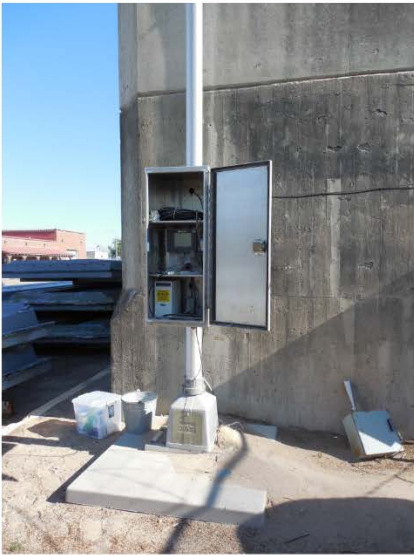
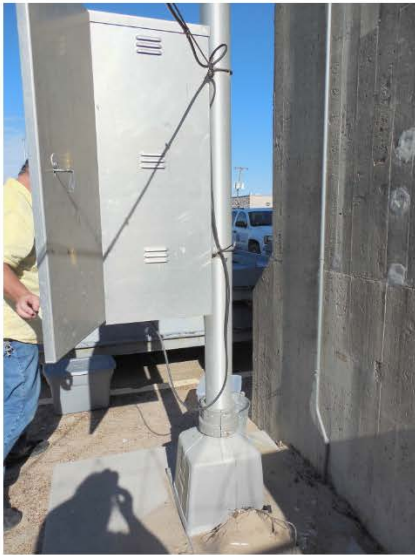
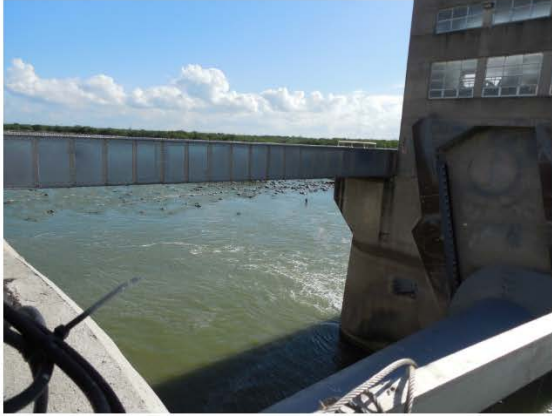
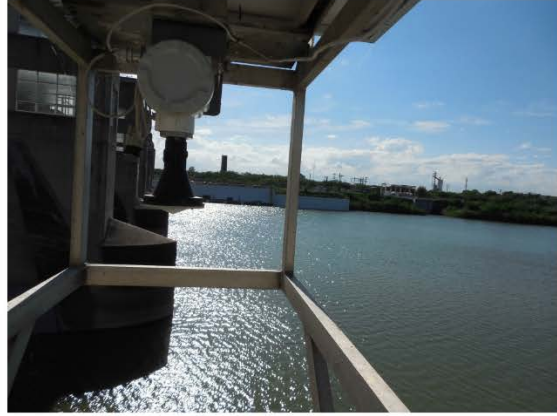
**Station C736 – Anzaldua’s Dam**

This station was being maintained by TCEQ in Harlingen, Texas, Watermaster's Office. Due to personnel changes, the station is now being monitored by TCEQ in Austin. Data is not being uploaded to website as station maintenance is not occurring frequently.

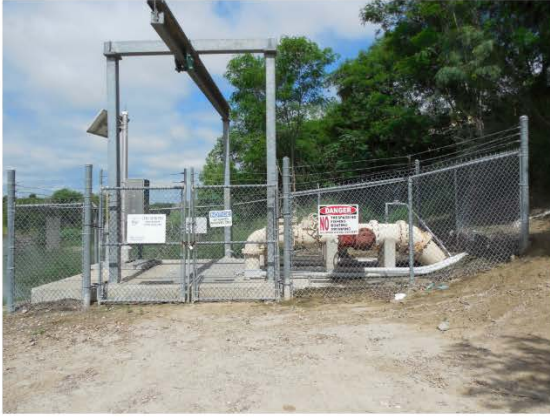
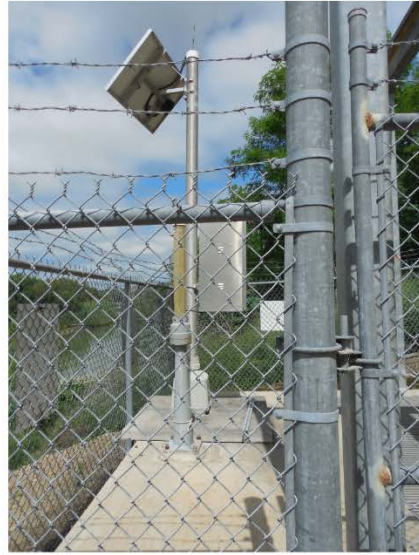
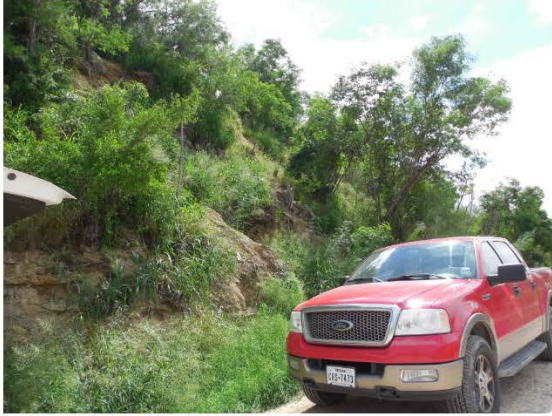
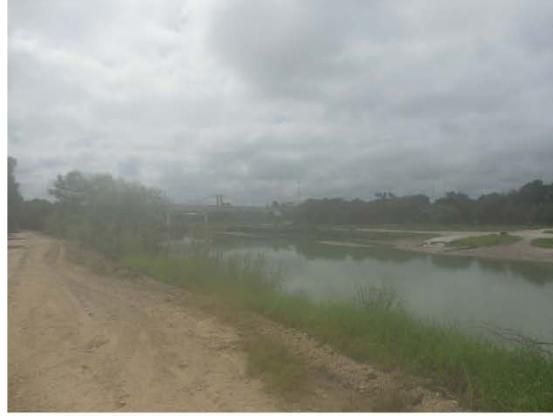
## Station C767 – Roma International Bridge

This station was being maintained by TCEQ in Harlingen, Texas, Watermaster's Office. Due to personnel changes, the station is now being monitored by TCEQ in Austin. Data is not being uploaded to website as station maintenance is not occurring frequently.

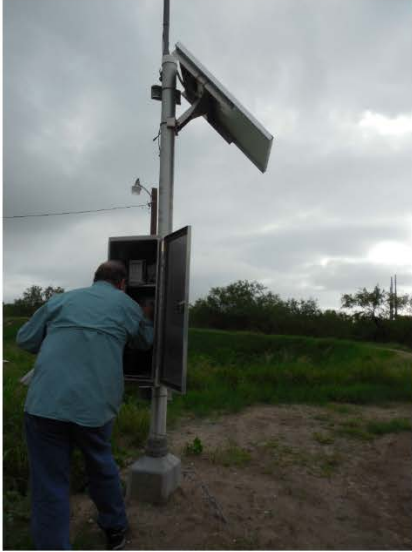
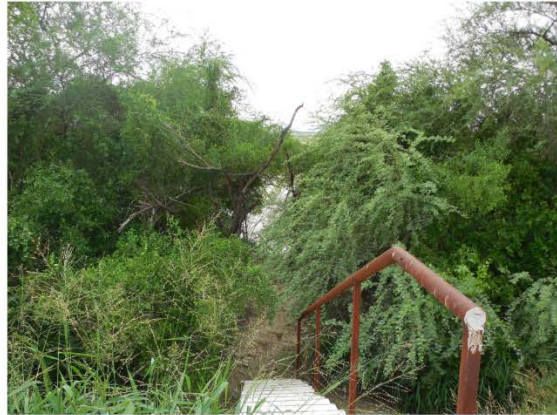
## Station C791 – United Irrigation Intake

This station was being maintained by TCEQ in Harlingen, Texas, Watermaster's Office. Due to personnel changes, the station is now being monitored by TCEQ in Austin. Data is not being uploaded to website as station maintenance is not occurring regularly.

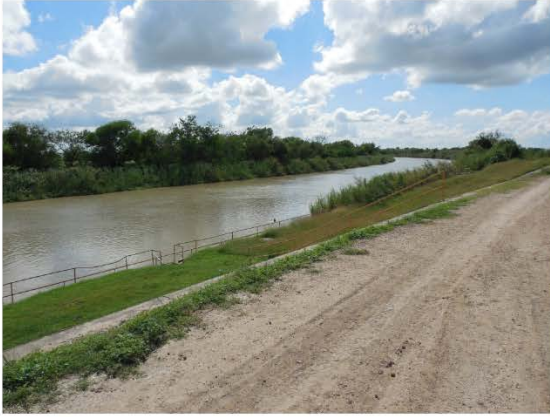
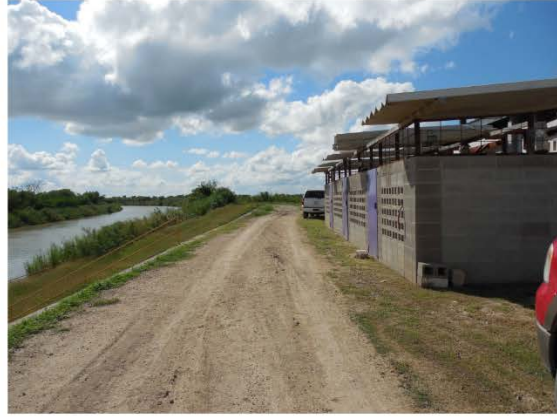
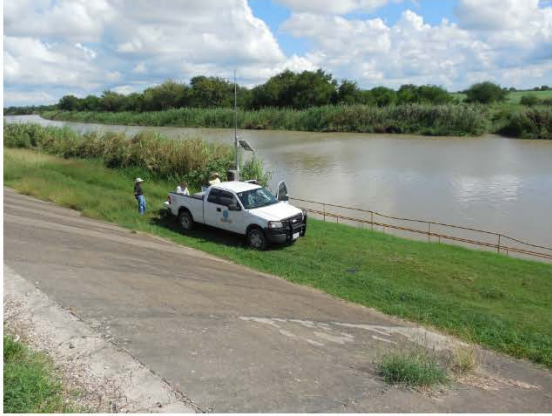
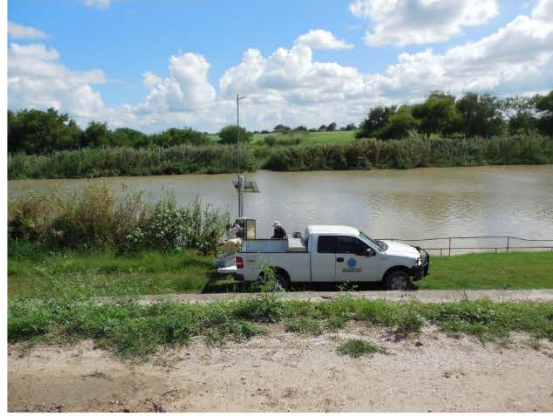
## Station C793 – HC & CC #9 Intake

This station was being maintained by TCEQ in Harlingen, Texas, Watermaster's Office. Due to personnel changes, the station is now being monitored by TCEQ in Austin. Data is not being uploaded to website as station maintenance is not occurring frequently.

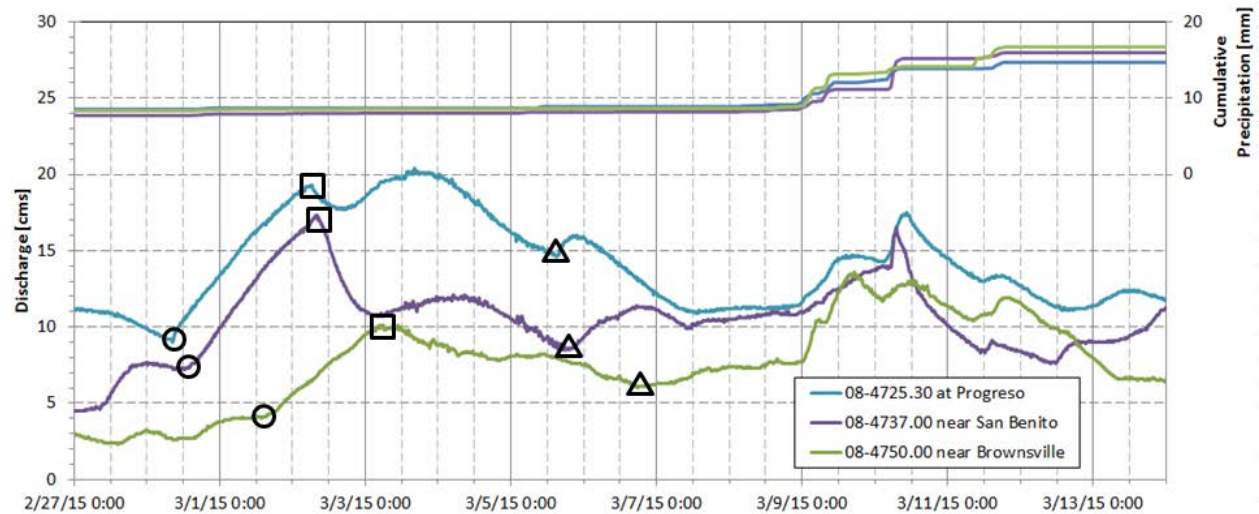
Figure 1. Hydrograph and cumulative precipitation for three IBWC gaging stations on the lower Rio Grande.

As an example, the data for the three lowest gages for early March of this year is plotted in the figure below. Discharge in cubic meters per second is plotted on the left y-axis; cumulative precipitation at the gage locations in millimeters is plotted on the right y-axis. Because of the influence of local precipitation after March 9<sup>th</sup>, data after that date is not suitable for estimating time-of-travel. Prior to that rainfall event, there are several opportunities to estimate time-of-travel between the gage locations based on features of the hydrographs. Those features are highlighted with a circle, square, or triangle in the figure. Flow conditions at this time are low (between 3 and 20 cms or about 100 to 700 cfs), well below the 1,130 cfs listed as the 25<sup>th</sup> percentile flow on page 9 of the report. For these conditions, the time-of-travel between the Progreso and San Benito gages ranges from 1.5 to 4.75 hours. From the Progreso to Brownsville gage, the values range from 22 to 30.5 hours. Keep in mind that these travel times are for very low flow conditions. At higher flow rates, travel times would be reduced from these values.
