Evaluation of Adopted Flow Standards for the Trinity River, Phase 2

For: Trinity and San Jacinto Rivers and Galveston Bay Stakeholder Committee through the Texas Water Development Board

Contract No. 1600011940
Final Report – November 2017

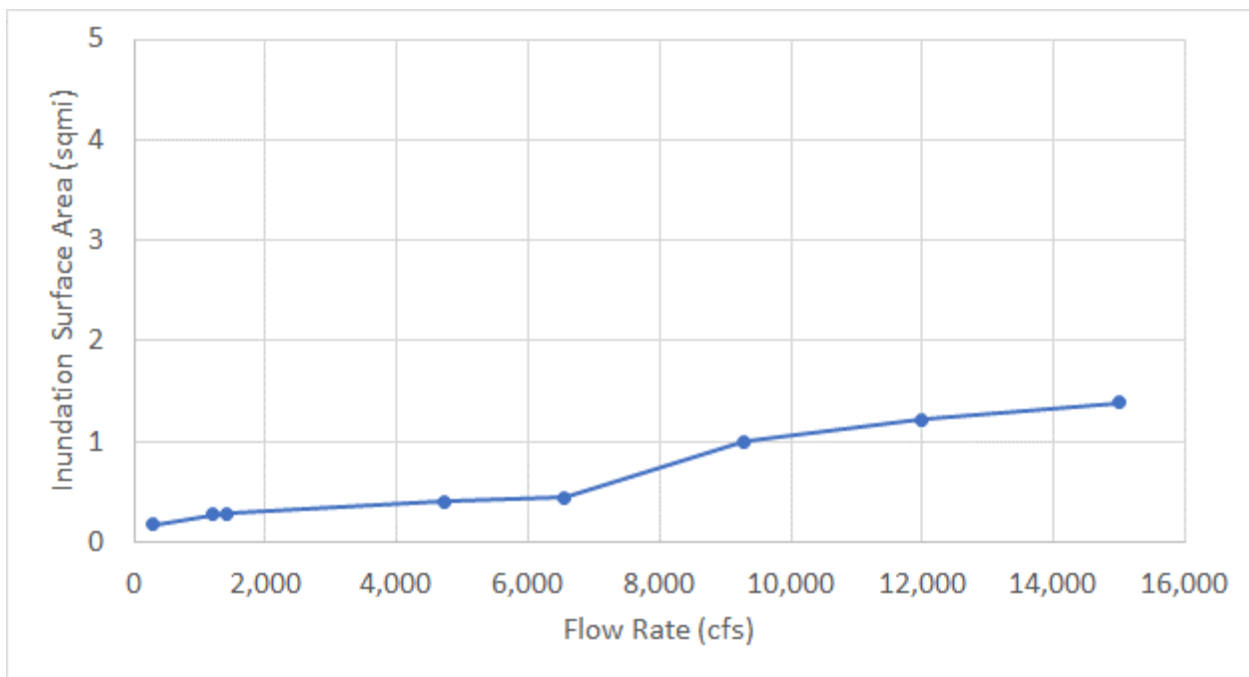
Figure 5. 080486 Grand Prairie - Inundation vs flow rate for pulse flows.

The urban site 080486 is located in Grand Prairie, within the Dallas/Fort Worth (DFW) metropolitan area. The channel is entrenched and is armored with rip rap in many locations. High flow pulses remain well within the banks with very little increase in inundated area as flow increases up to 15,000 cfs, the highest pulse observed during the study (Figure 5).

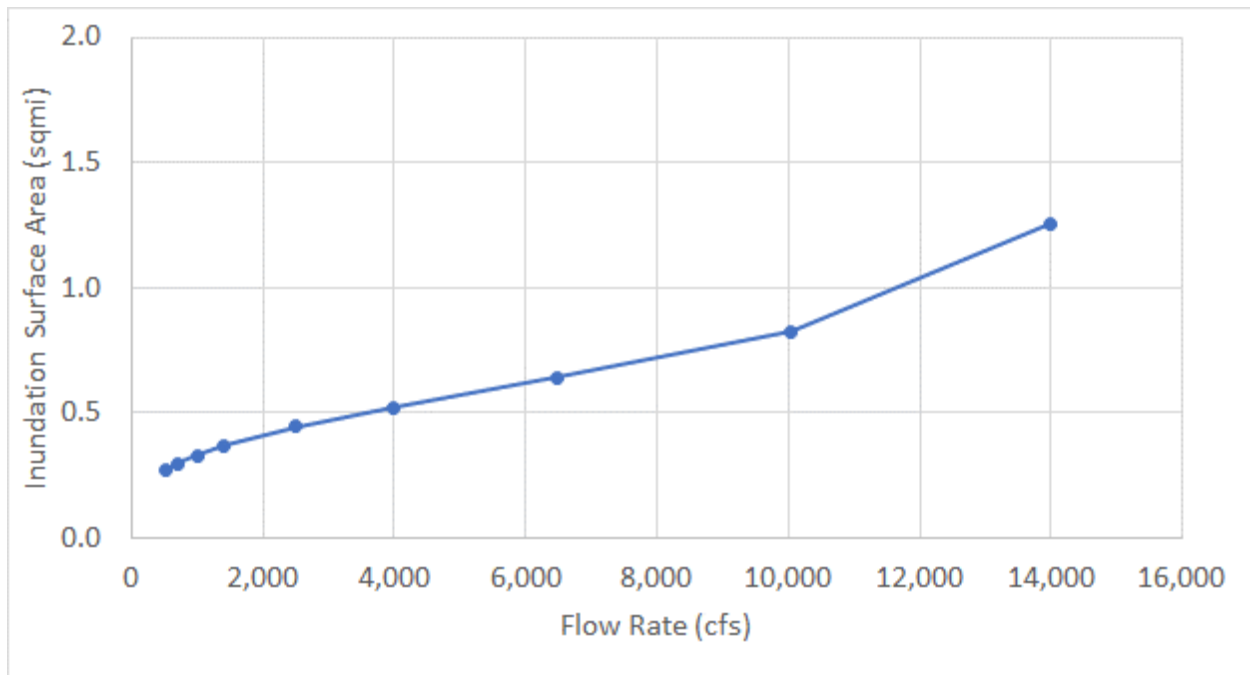
Figure 6. 080444 Dallas lock site - Inundation vs flow rate for pulse flows.

The lock site 080444 is located south of Dallas within a stream segment that is highly modified. Adjacent to the channel are flood control levees and within the channel exist lock and dam structures. Both locks within this reach have recently been flanked (erosion caused water to bypass the century-old structures). Up to 14,000 cfs, the river stays between the main banks of the river and does not overflow into the floodplain toward the levees (Figure 6). The riparian area adjacent to this site is affected since the floodplain is narrow between the levees. Primary connectivity of the river channel to the riparian area within this segment is through over banking flows on the lower half of this segment. Some inundation of backwater and oxbows occurs in the upper half of the reach near Interstate I-20 and the USGS gage Trinity River below Dallas (08057000).

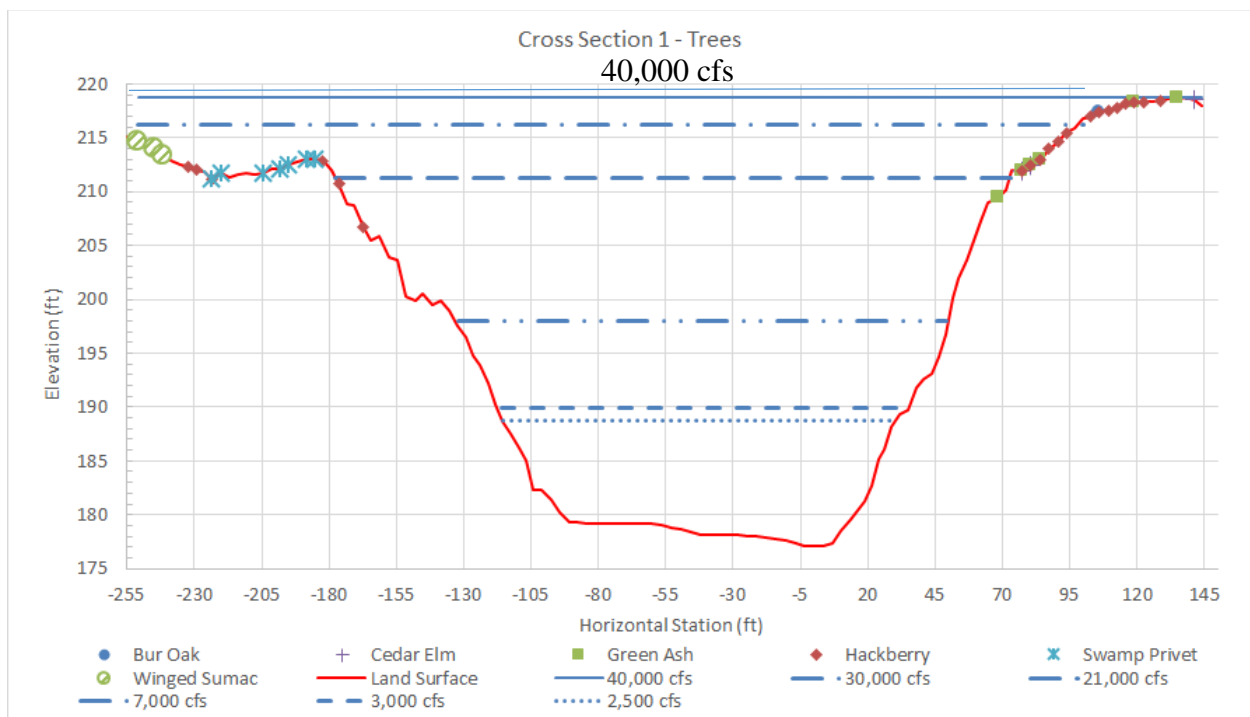
Figure 20. 080295 XS1 – Upstream riparian cross-section trees with flow levels. Note: 7,000 cfs, 3,000 cfs, and 2,500 cfs correspond to the SB3 pulses required for this site.

Additional analysis of pulse flow effects at the two riparian cross-sections was performed to evaluate the depth of water based on HEC-RAS modeled results (Mangham, Osting and Flores 2015). At these two cross-sections, flows ranging from 21,000 cfs to 30,000 cfs begin to provide inundation to the riparian forest community (Figure 20 through Figure 25). At 30,000 cfs the model predicts approximately 2 ft. depth of inundation over cross-section 1 left river bank benchmark and approximately 4 ft. depth at cross-section 2 left river bank benchmark.

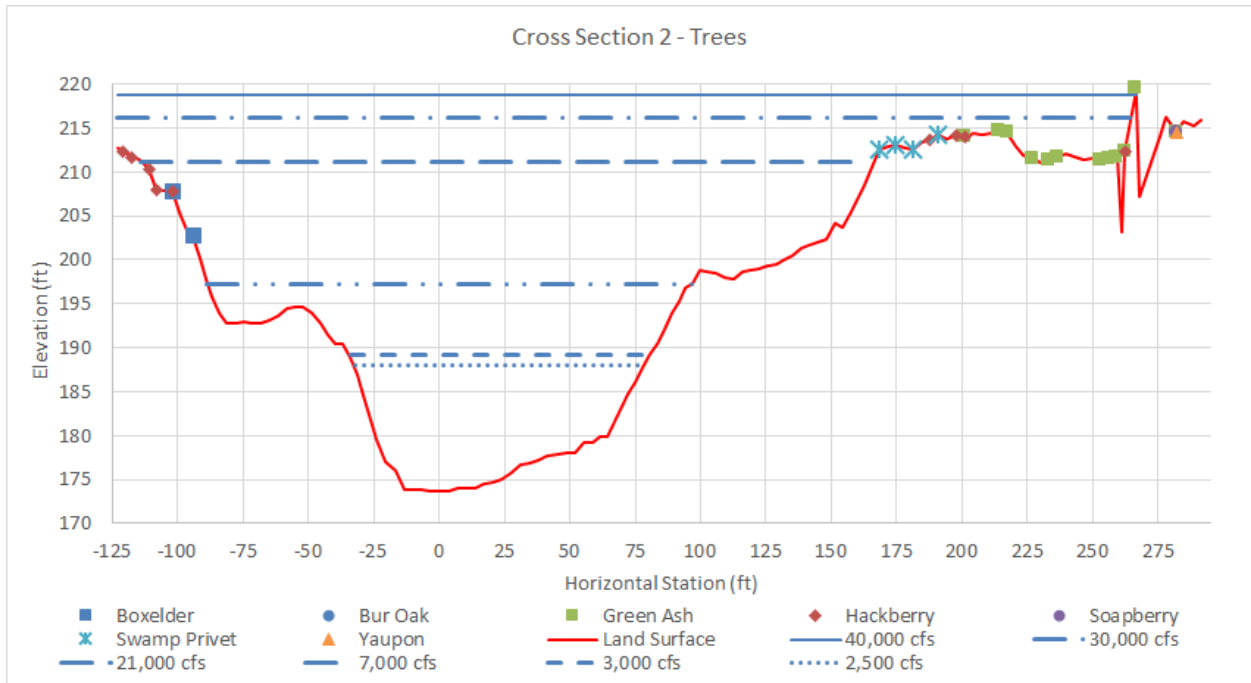
Figure 23. 080295 XS2 – Middle riparian cross-section trees with flow levels. Note: 7,000 cfs, 3,000 cfs, and 2,500 cfs correspond to the SB3 pulses required for this site.

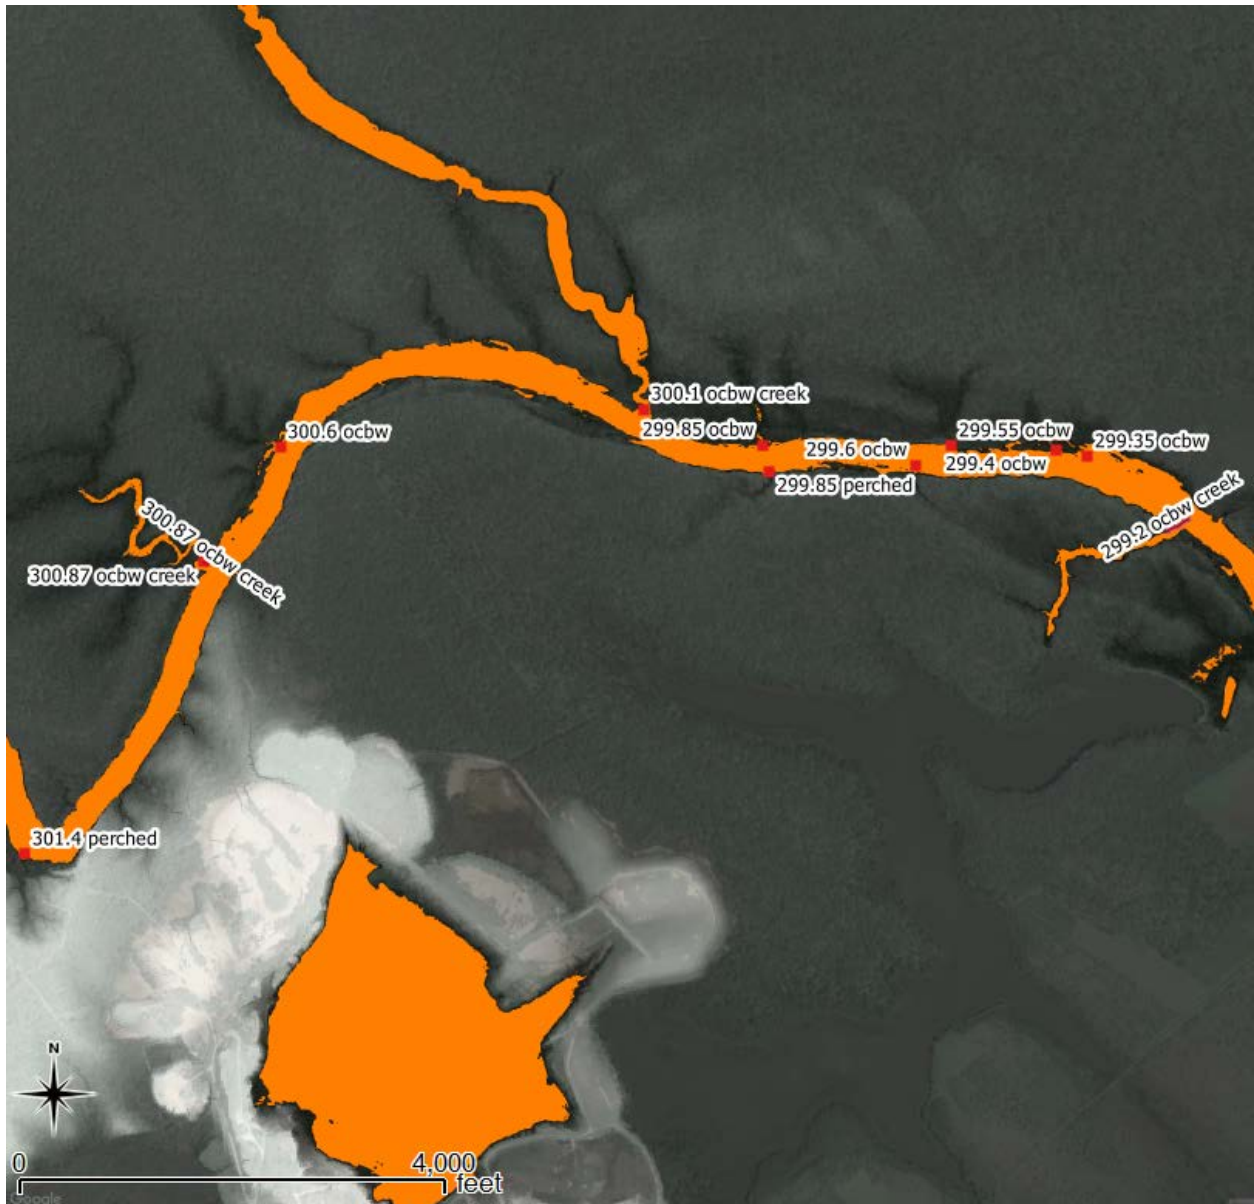
Figure 27. Segment C3 upstream of 080295 1 of 4- Observed inundation and connectivity areas over the RAS 13400cfs inundation map (orange). Note: Numbers represent approximate river mile.

Additionally, WSE and flow was collected as validation of the water surface profile (HEC-RAS) modeling efforts. Based upon mapping and inspection, the previous modeling appeared to adequately predict islands as is evident by the the mapping efforts (Figure 26 through Figure 29). Among the vegetation, velocities were slow. Flow at the Oakwood gage were between 15,600 and 13,200 cfs (stage difference of 1.2 feet); on-site observed flow (M9) was between 16,400 and 12,300 cfs.

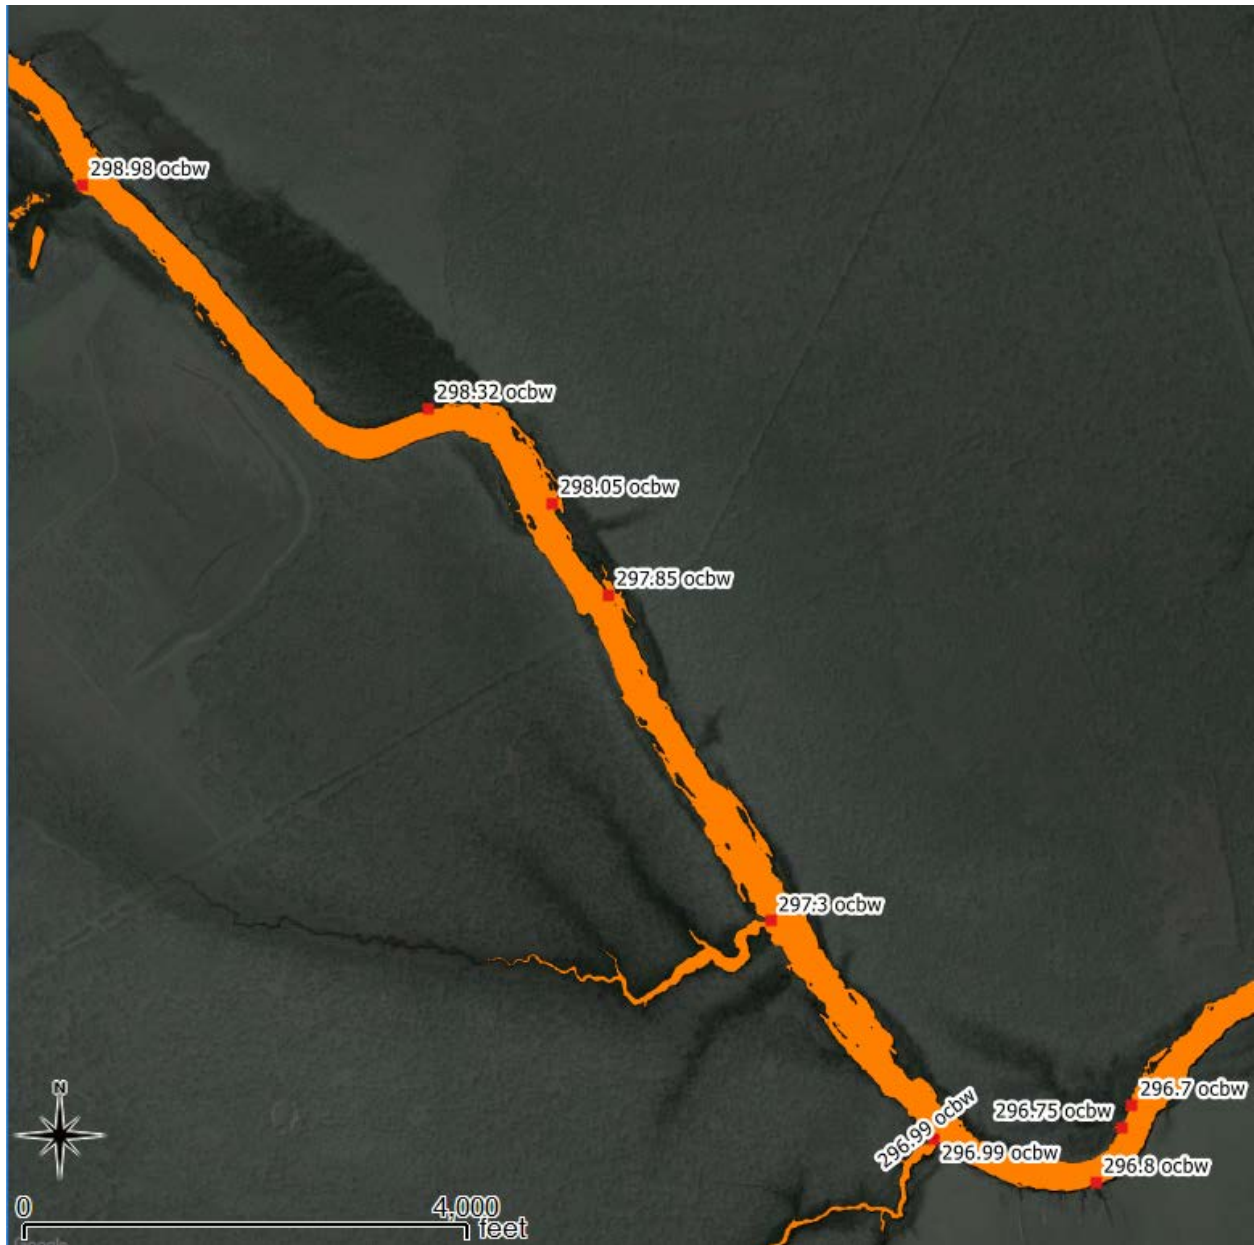
Figure 28. Segment C3 upstream of 080295 2 of 4 - Observed inundation and connectivity areas over the RAS 13400cfs inundation map (orange). Note: Numbers represent approximate river mile.

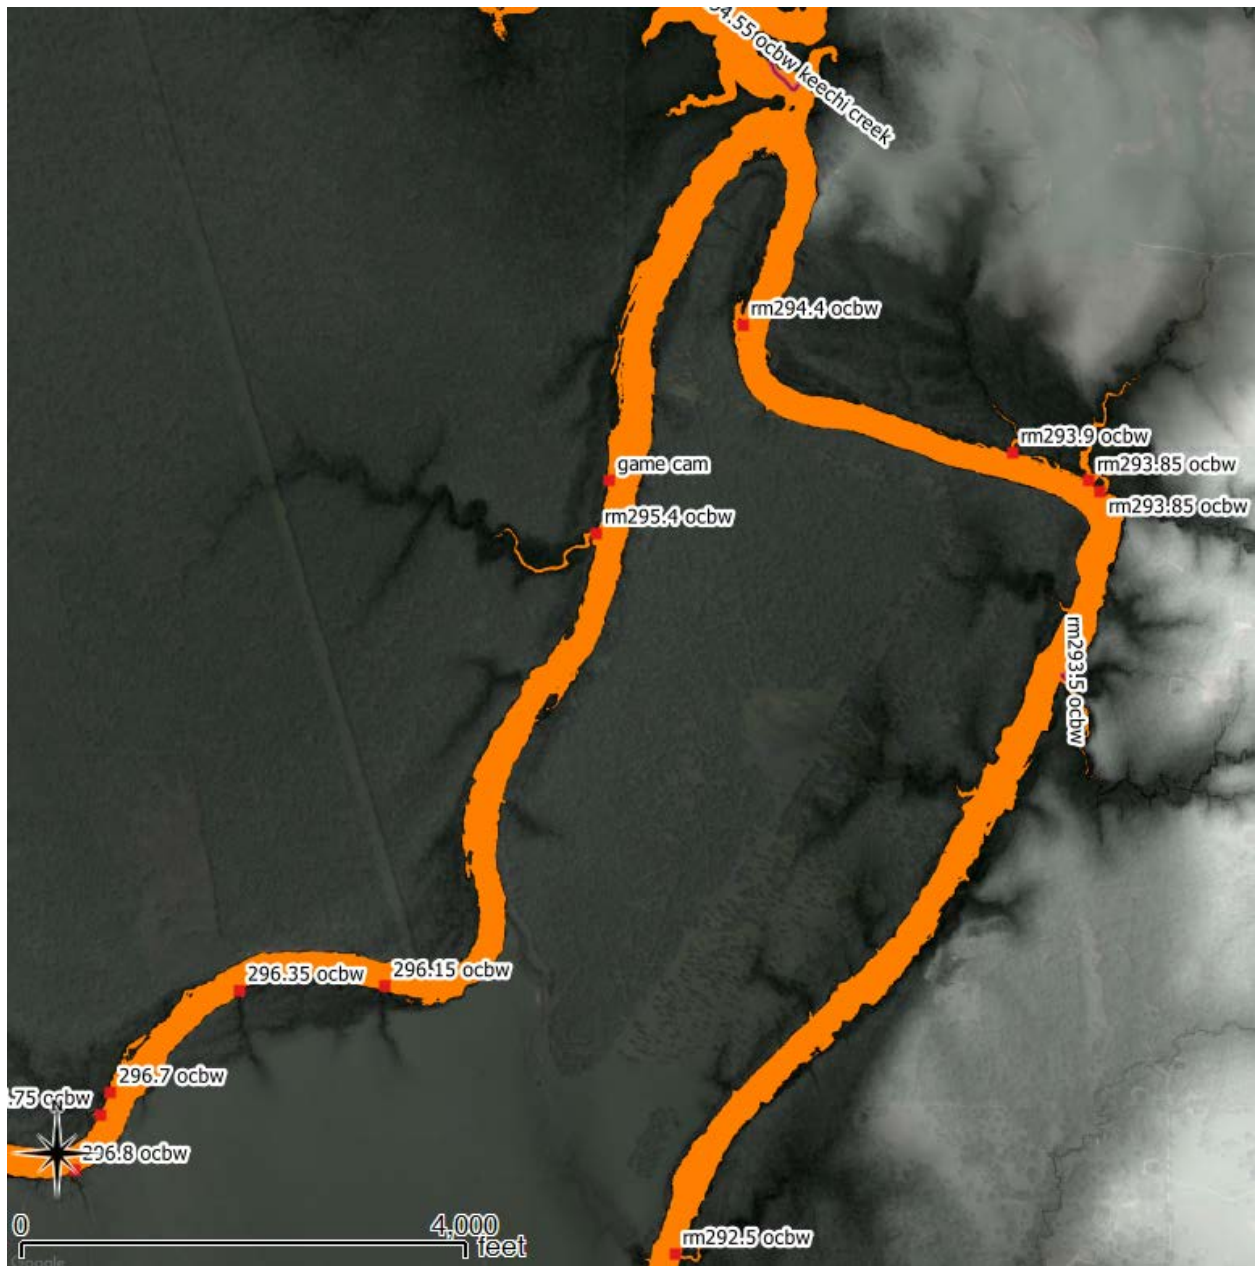
Figure 29. Segment C3 upstream and downstream of 080295 3 of 4 - Observed inundation and connectivity areas over the RAS 13400cfs inundation map (orange). Note: Numbers represent approximate river mile.

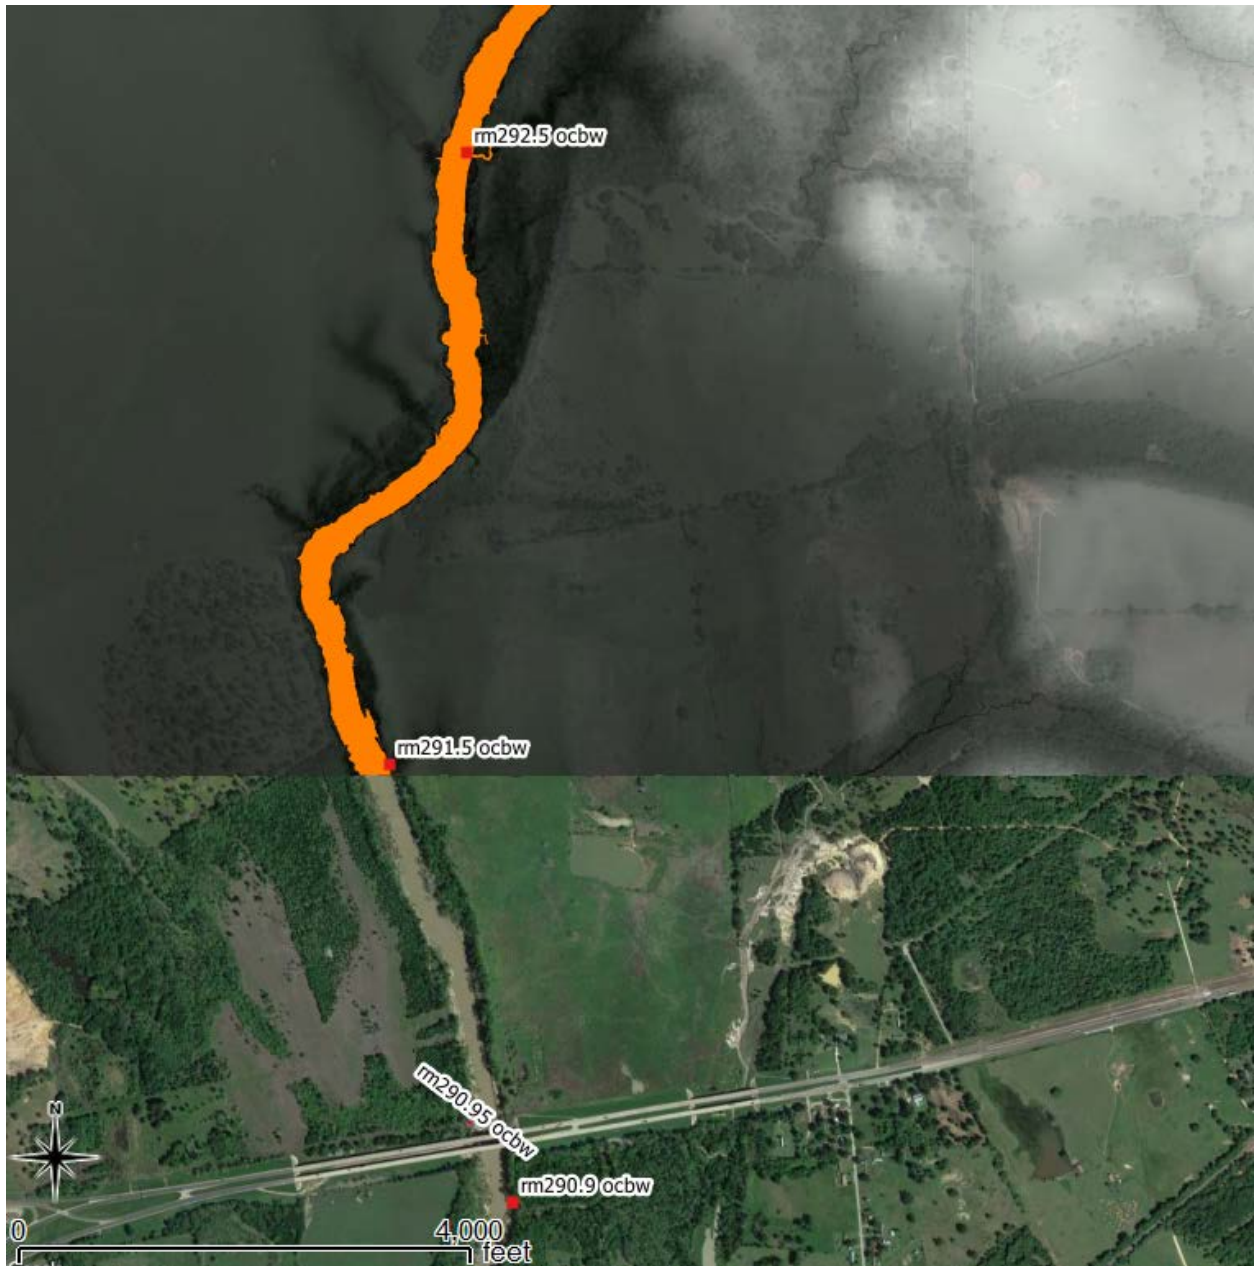
Figure 30. Segment C3 downstream of 080295 4 of 4 - Observed inundation and connectivity areas over the RAS 13400 cfs inundation map (orange). Note: Numbers represent approximate river mile.

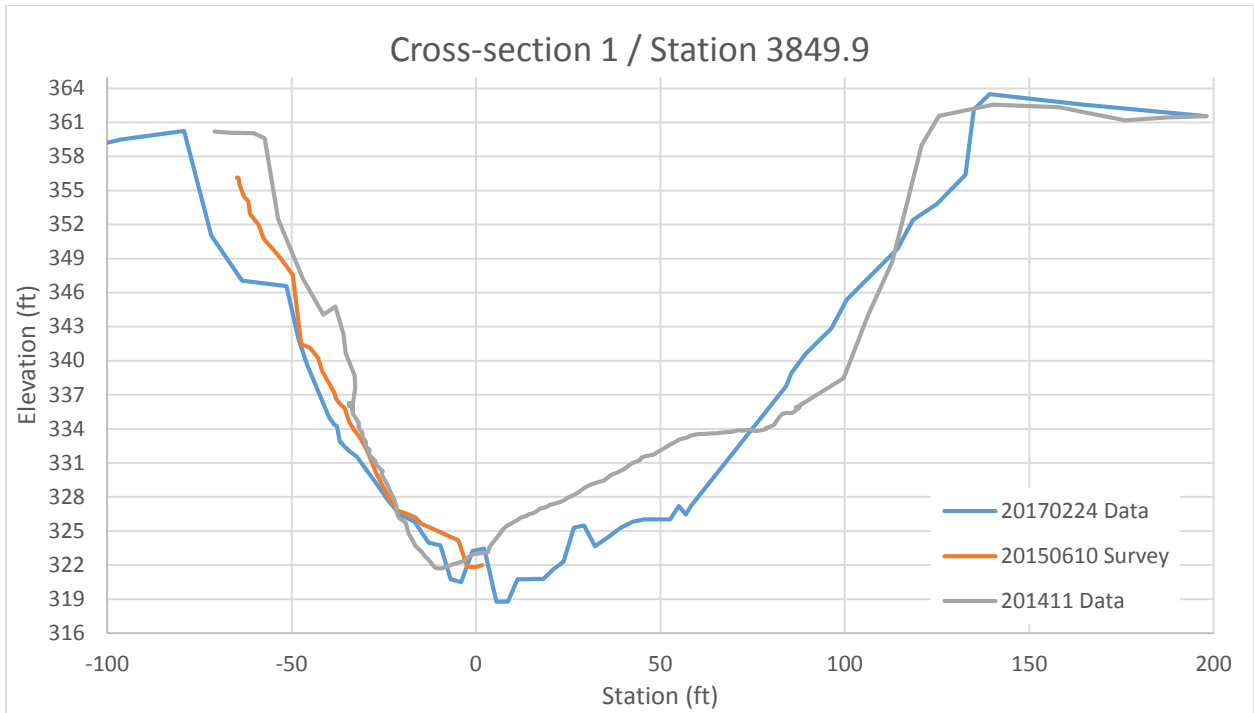
Figure 48. Changes in cross-section at station 3849.9.

Below are figures showing changes in five cross-sections from the 2014, 2015 and 2017 surveys.

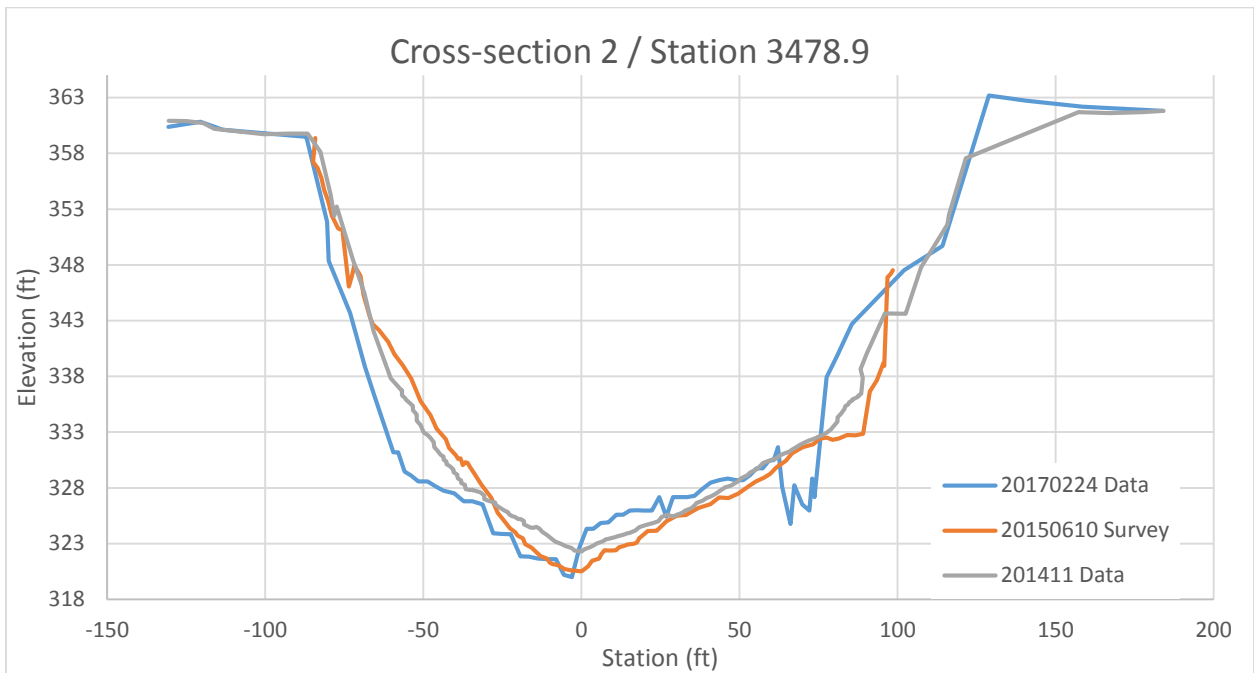
Figure 49. Changes in cross-section at station 3478.9.

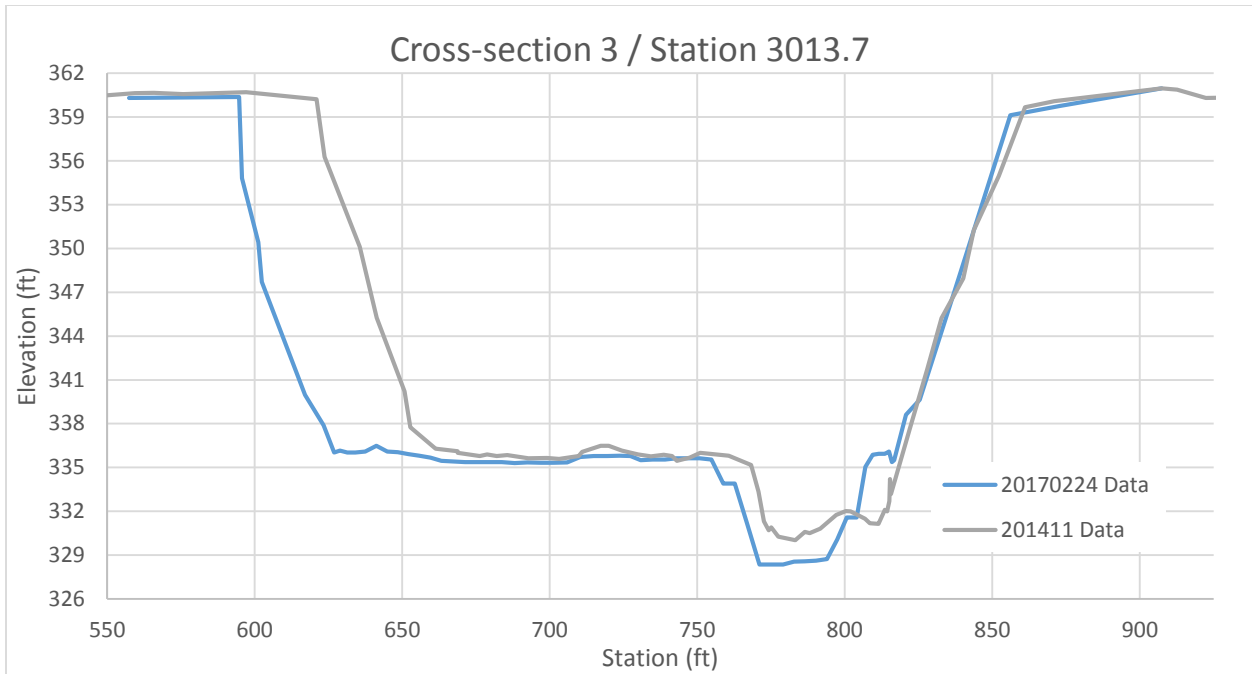
Figure 50. Changes in cross-section at station 3013.7.

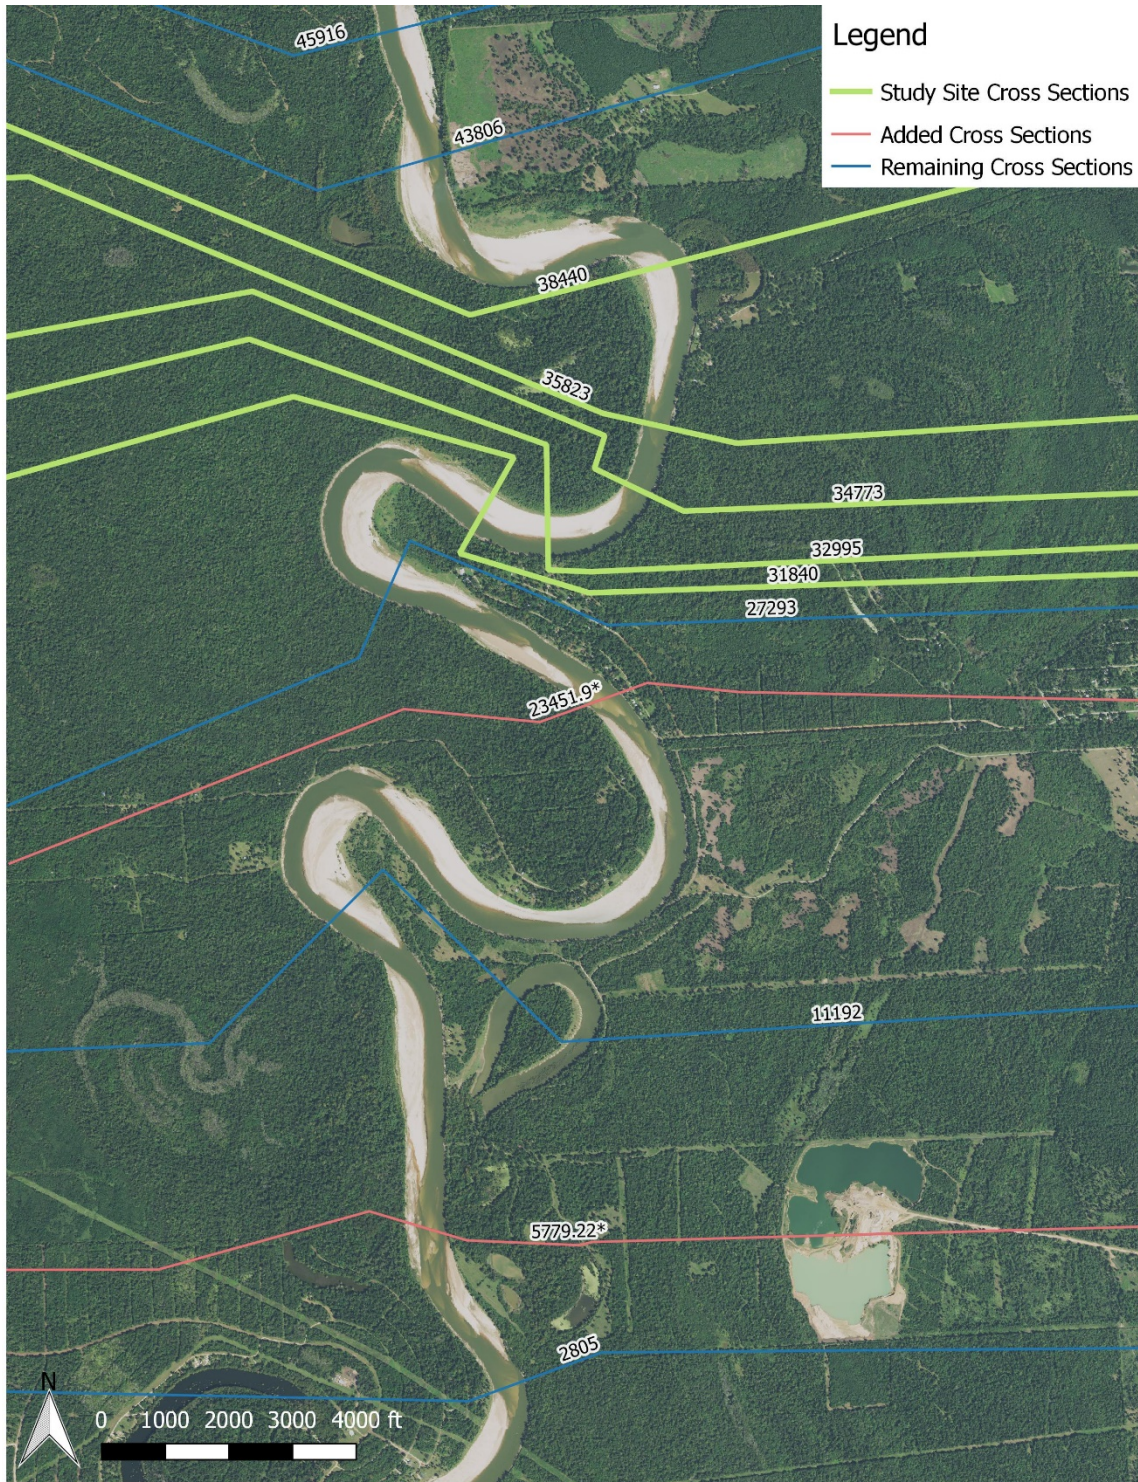
Figure 84. Map of existing and added cross-sections for the Romayor HEC-RAS model.

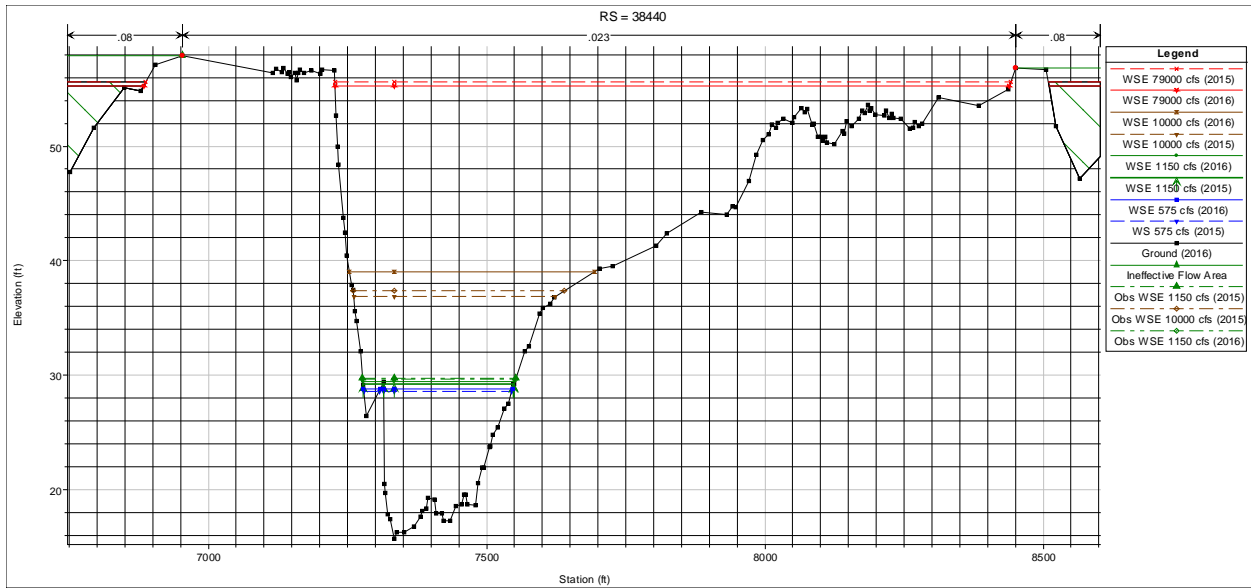
Figure 87. Cross-section 38440 water surface elevations for certain modeled flow rates for 2015 and 2016 survey data.
