Increasing the Safety of Hays County Citizens and First Responders through Hydrologic Data, Flood Cameras and Low Water Crossing Monitoring

Written by: Justin McInnis
Interim Director
Hays County Office of Emergency Services
justin.mcinnis@co.hays.tx.us
512-393-7300

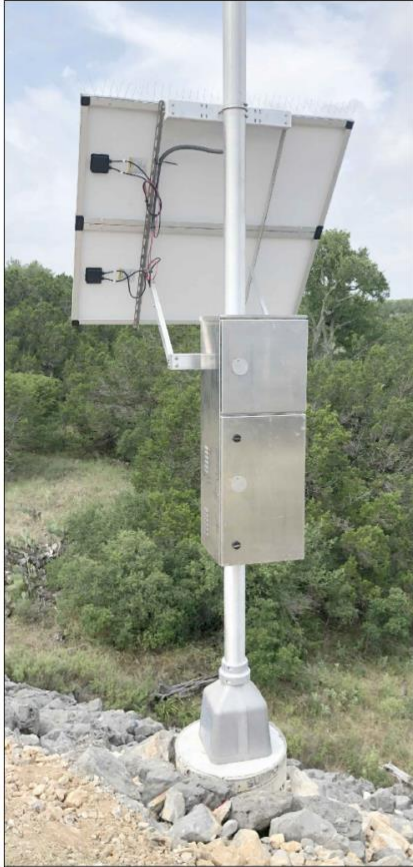
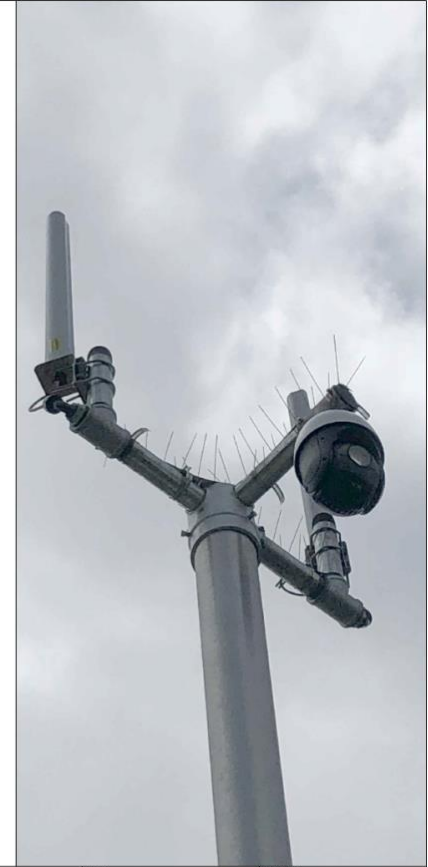
Designed: EEC	Title: NRCS DAM 4 CAMERA STATION STATION DETAILS #2	Scale: NOT TO SCALE	Project No: HC001
Drawn: EEC		Copy: AS BUILT	Drawing: 3
Checked: MLR			
Edt: 8-14-2019	Filepath: C:\WET\Folders\Water & Earth Technologies\WET Folders - Documents\Clients\Hays County TX\AutoCAD\AS BUILT\CAMERA\NRCS DAM 4 CAMERA\NRCS DAM 4 CAMERA.dwg
