Prepared in cooperation with the U.S. Department of Agriculture Natural Resources Conservation Service, the Edwards Region Grazing Lands Conservation Initiative, the Texas State Soil and Water Conservation Board, the San Antonio River Authority, the Edwards Aquifer Authority, Texas Parks and Wildlife, the Guadalupe Blanco River Authority, and the San Antonio Water System

## Effects of Brush Management on the Hydrologic Budget and Water Quality In and Adjacent to Honey Creek State Natural Area, Comal County, Texas, 2001–10

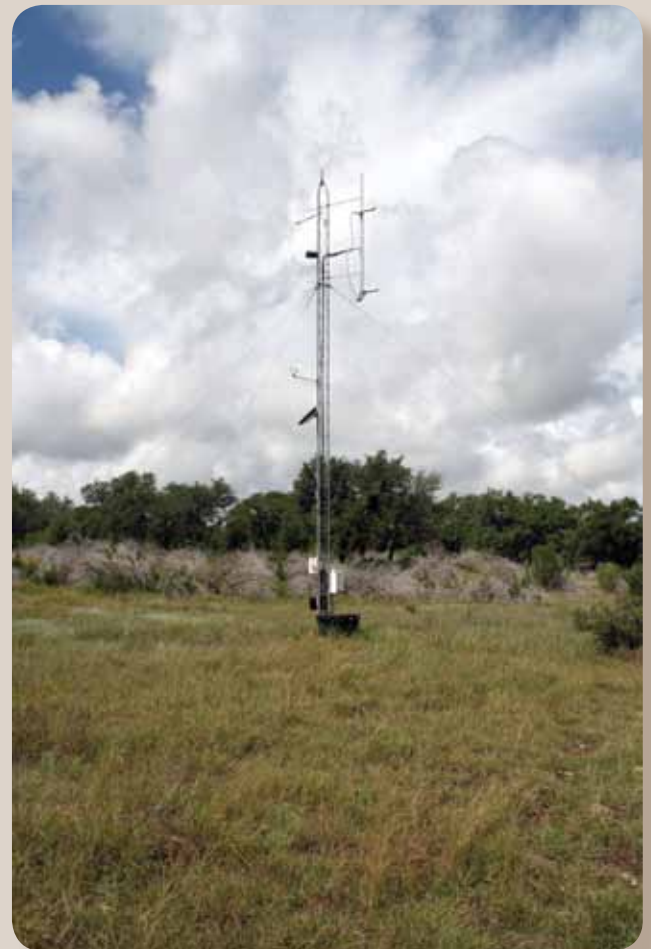
**Figure 1.** Evapotranspiration station in the treatment watershed at site TWS<sub>ET</sub> (U.S. Geological Survey station 295102098283200 Honey Creek treatment evapotranspiration near Spring Branch, Texas), Honey Creek State Natural Area, Comal County, Tex., July 23, 2010.

- Daily evapotranspiration rates at the reference watershed site  $RWS_{ET}$  (USGS station 295104098285900 Honey Creek reference evapotranspiration near Spring Branch, Tex.; fig. 2) and the treatment watershed site  $TWS_{ET}$  (USGS station 295102098283200 Honey Creek treatment evapotranspiration near Spring Branch, Tex.; fig. 2) exhibited a seasonal cycle during the pre- and post-treatment periods, with intraannual and interannual variability (fig. 4). Statistical analyses indicate that the mean difference in daily evapotranspiration rates between the two sites ( $RWS_{ET} - TWS_{ET}$ ) is greater during the post-treatment period than it was during the pre-treatment period.

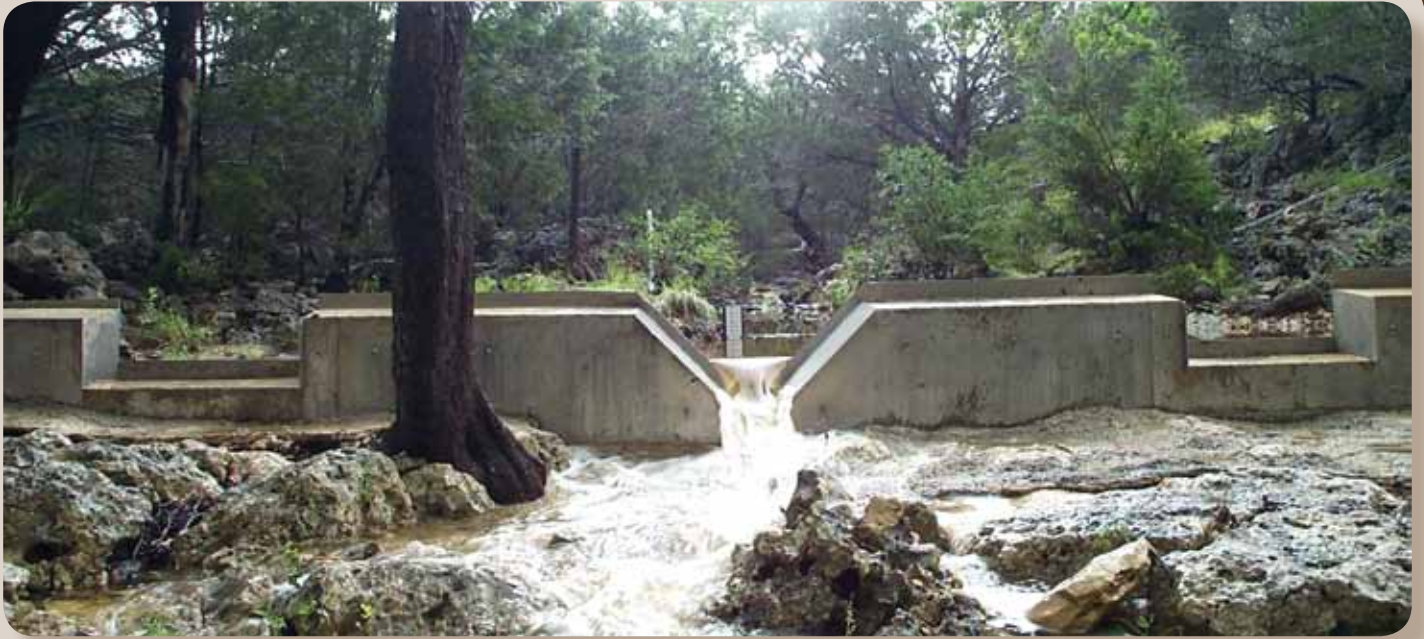
**Figure 3.** Streamflow-gaging stations were installed in the study area, such as this weir in the treatment watershed at site 2T (U.S. Geological Survey station 08167353 Unnamed tributary of Honey Creek site 2T near Spring Branch, Texas), Honey Creek State Natural Area, Comal County, Tex.
