Geology of the Carrizo sand by A.N. Sayre and S.F. Turner

DEWATERING OF THE CARRIZO SAND, DIMMIT COUNTY, TEXAS, 1929 - 57.

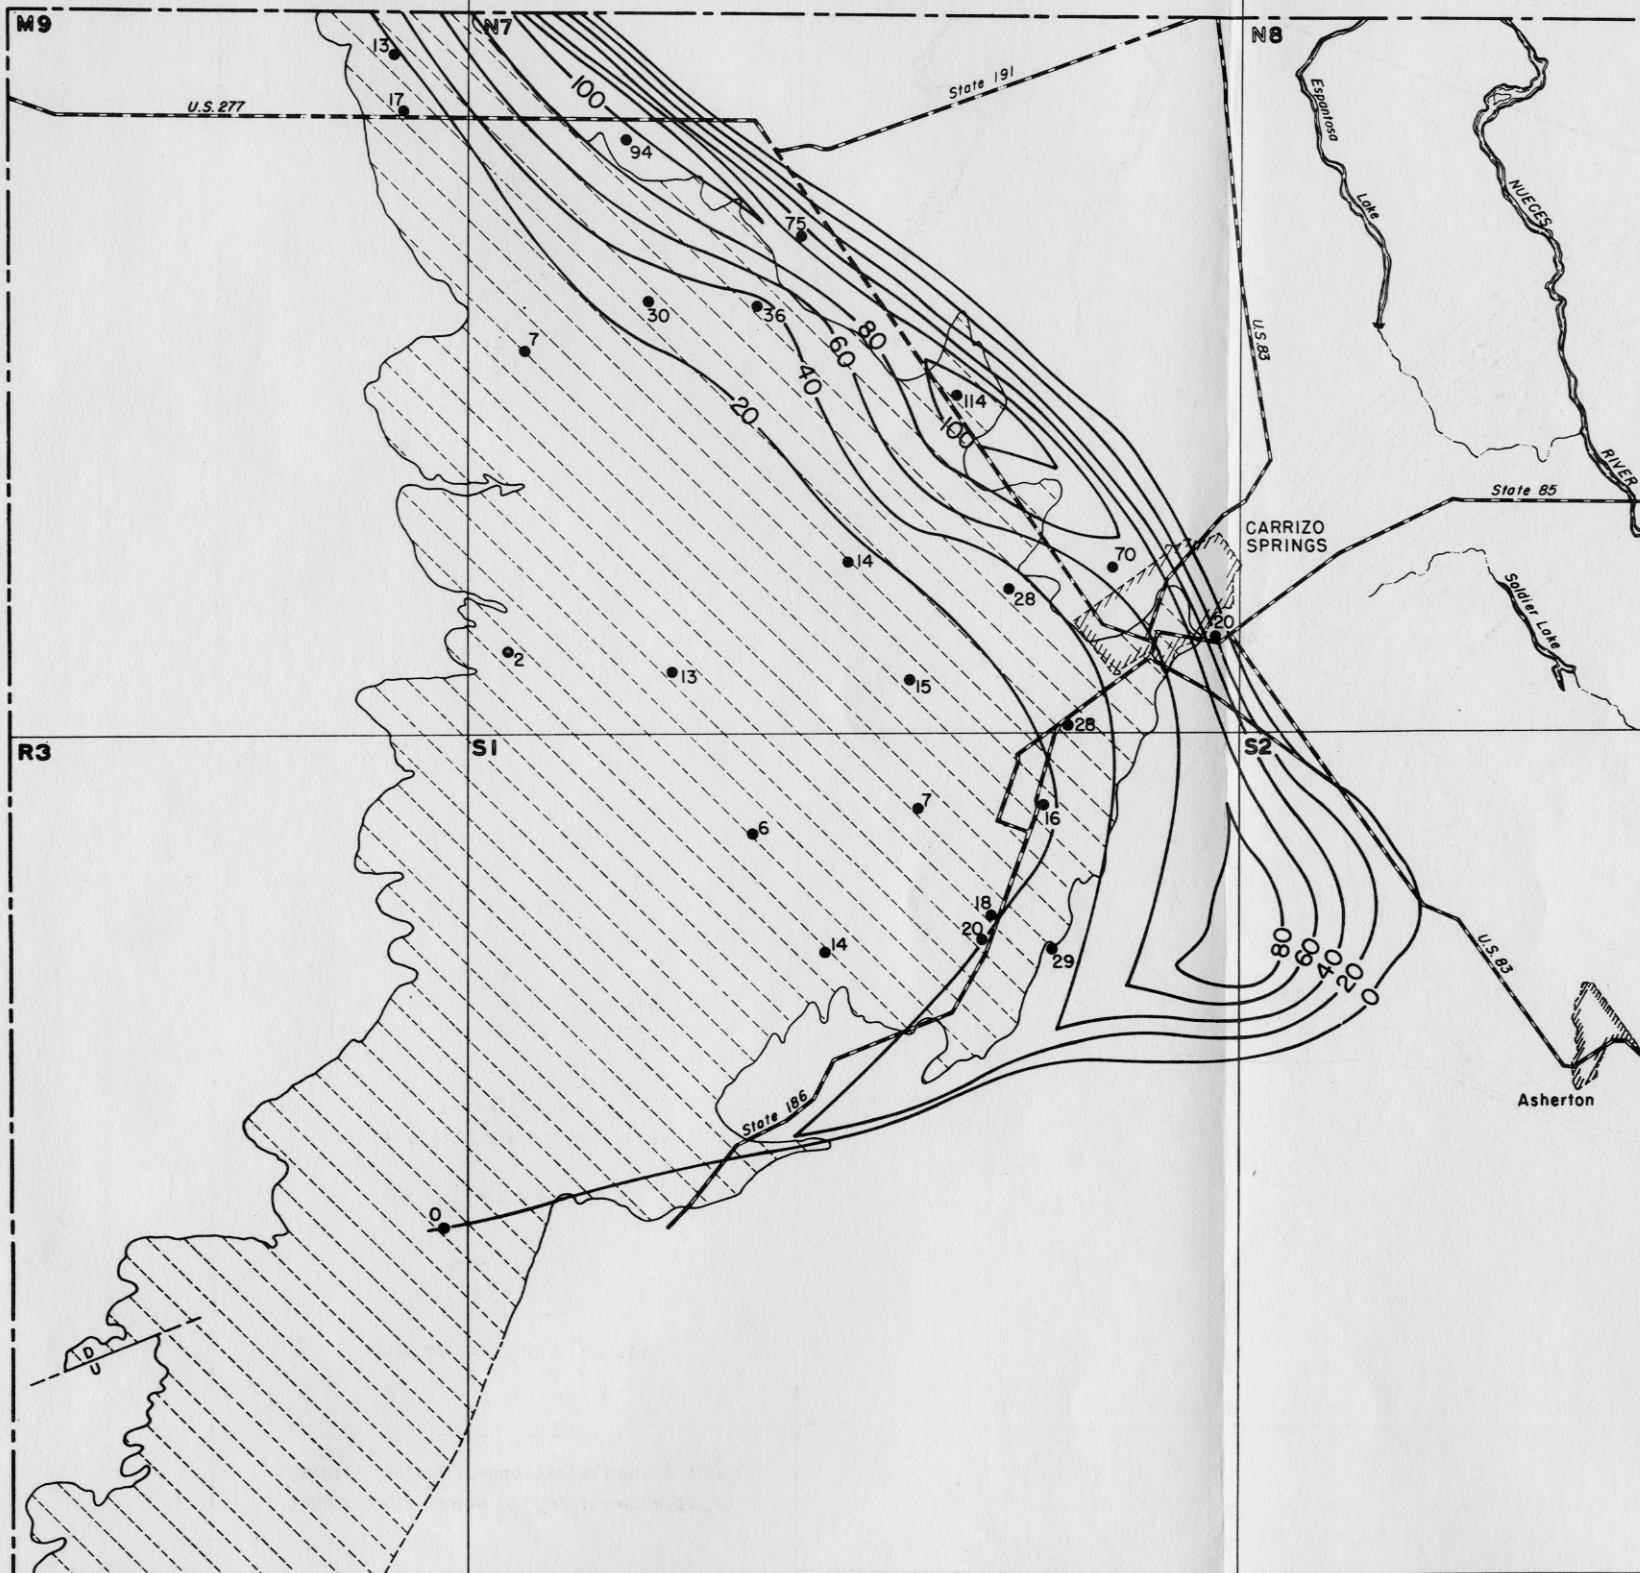
- 36
Well used for control. Number indicates the dewatering, in feet
- 40 —
Line showing the dewatering, in feet
- Contour interval, 20 feet
-
